RESIDENTIAL APPRAISAL REPORT

# 1200 Sample Crescent, Saanich, BC V0V 0V0

Effective October 14, 2026 · Prepared by Example Appraisal Co. (fictional) · File EX-2026-0147

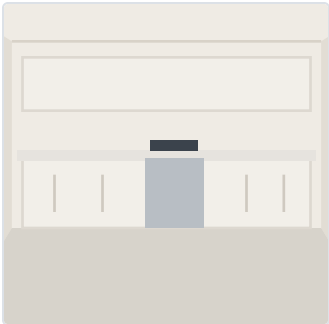
16 Kitchen (2018)

| YEAR | ITEM | WORK |
|---|---|---|
| 2018 | Kitchen | Shaker cabinets, quartz counters, tile floor, new appliances |

| LEVEL | ROOM | SIZE | FLOORING | FINISHES | CONDITION |
|---|---|---|---|---|---|
| Main | Kitchen | 12'6" × 11'0" | Tile | Quartz, shaker cabinets (2018) | Good |
